TECHNICAL REPORT REMR-CO-3

CASE HISTORIES OF CORPS BREAKWATER
AND JETTY STRUCTURES

Report 6

NORTH PACIFIC DIVISION

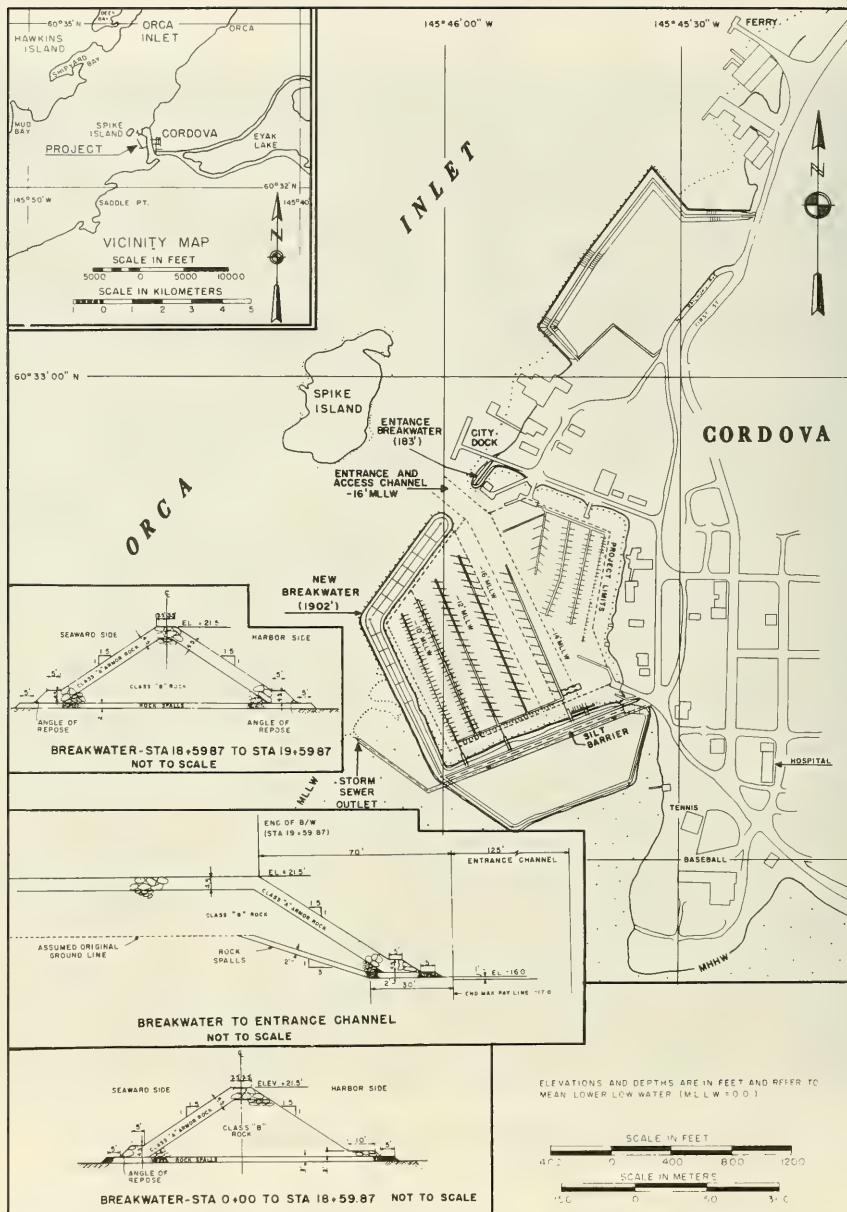
Figure 5. Site layout of Cordova Harbor, Alaska (revised 1985)

1985	The harbor is illustrated in Figure 5, and an aerial photograph of the harbor is presented in Figure 6. The breakwaters appear in good condition at this time.

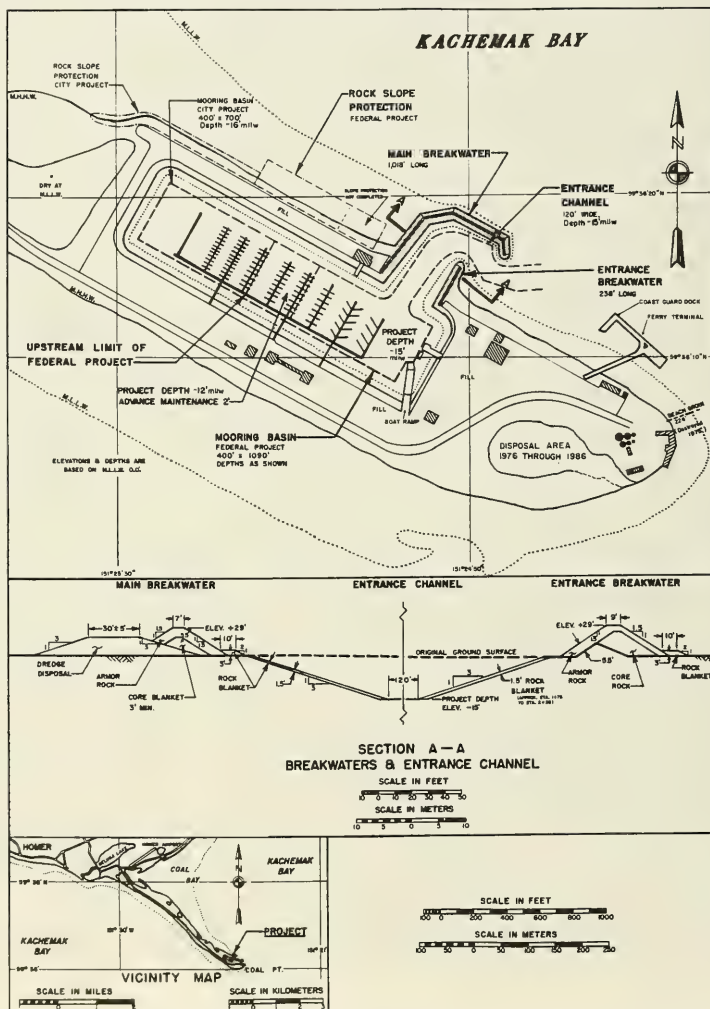
Figure 13. Site layout of Homer Harbor prior to expansion during 1984-1985 (revised 1978)

Date(s)	Construction and Rehabilitation History
1958	The original harbor plan was adopted.
1962	The original harbor was completed, including a 180- by 672-ft basin (2.8 acres), and a 1,260-ft rubble-mound breakwater.
1964	The original harbor was destroyed by earthquake, and the breakwater was severely damaged.
1965	The harbor was restored and relocated slightly to the northwest. The restored harbor included 2.75 acres at -12 ft mllw and 7.25 acres at -15 ft mllw, protected by a 1,018-ft main breakwater and a 238-ft entrance breakwater. Both breakwaters were constructed of a quarry-run core covered with an armor layer to crest elevation of +29 ft mllw with 1:1.5 side slopes. The main breakwater had a 7-ft crest width and was covered with a 5.5-ft layer of armor rock. The entrance breakwater had a 9-ft crest width and was covered with a 5.5-ft layer of armor rock on the entrance side and a 3-ft layer on the seaward side. The main breakwater had a rock blanket 3 ft thick extending 10 ft past the toe on the entrance side. The entrance breakwater had a 3-ft-thick rock blanket extending 10 ft past the toe on the seaward side. Armor rock was 700 to 1,100 lb. The entrance channel was dredged to -15 ft mllw and 120 ft wide at project depth, with 1:3 side slopes protected by a 1.5-ft-thick rock blanket. Cross sections of the breakwaters are shown in Figure 13.

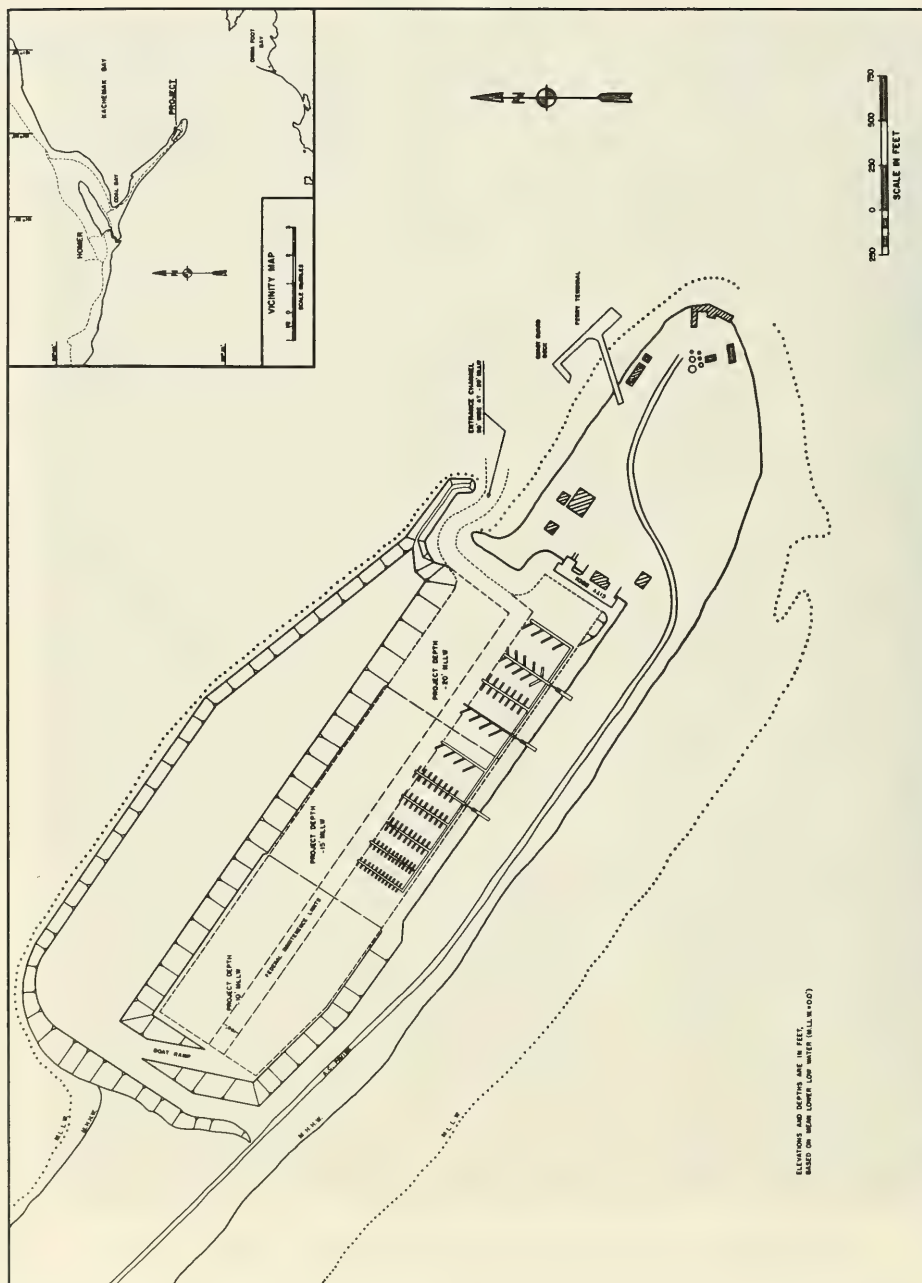
Figure 15. Site layout of Homer Harbor, Alaska, after expansion during 1984-1985 (revised 1985)

Date(s)	Construction and Rehabilitation History
	15 percent less than 250 lb), and a 4.5-ft layer of primary armor rock (Class "A", 1,100 to 3,000 lb, 50 percent between 1,500 and 1,900 lb).
1985	The breakwaters are in good condition at this time.

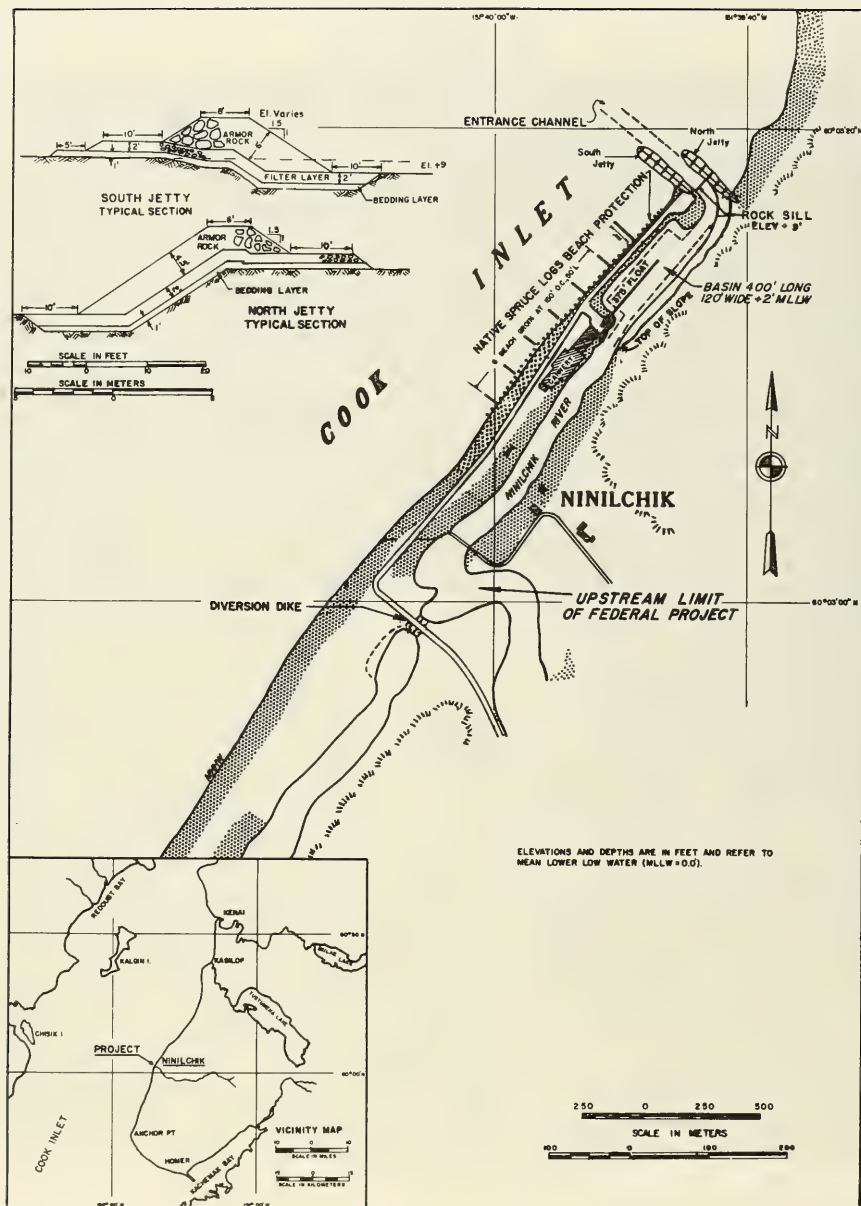
Figure 34. Layout of Ninilchik Harbor, Alaska (revised 1981)

1967	Major rehabilitation of the harbor was done. The Ninilchik River was diverted to its previous course south of the basin, and two short rubble-mound jetties were constructed at the river mouth. Jetty cross sections are shown in Figure 34.
1980	A study was authorized to determine the feasibility of harbor improvements.
1984	The study determined that improvements to the harbor would not be cost effective.
1985	The harbor is illustrated in Figure 34, and an aerial photograph of the harbor is presented in Figure 35. The harbor has required annual maintenance dredging and repairs since its construction.

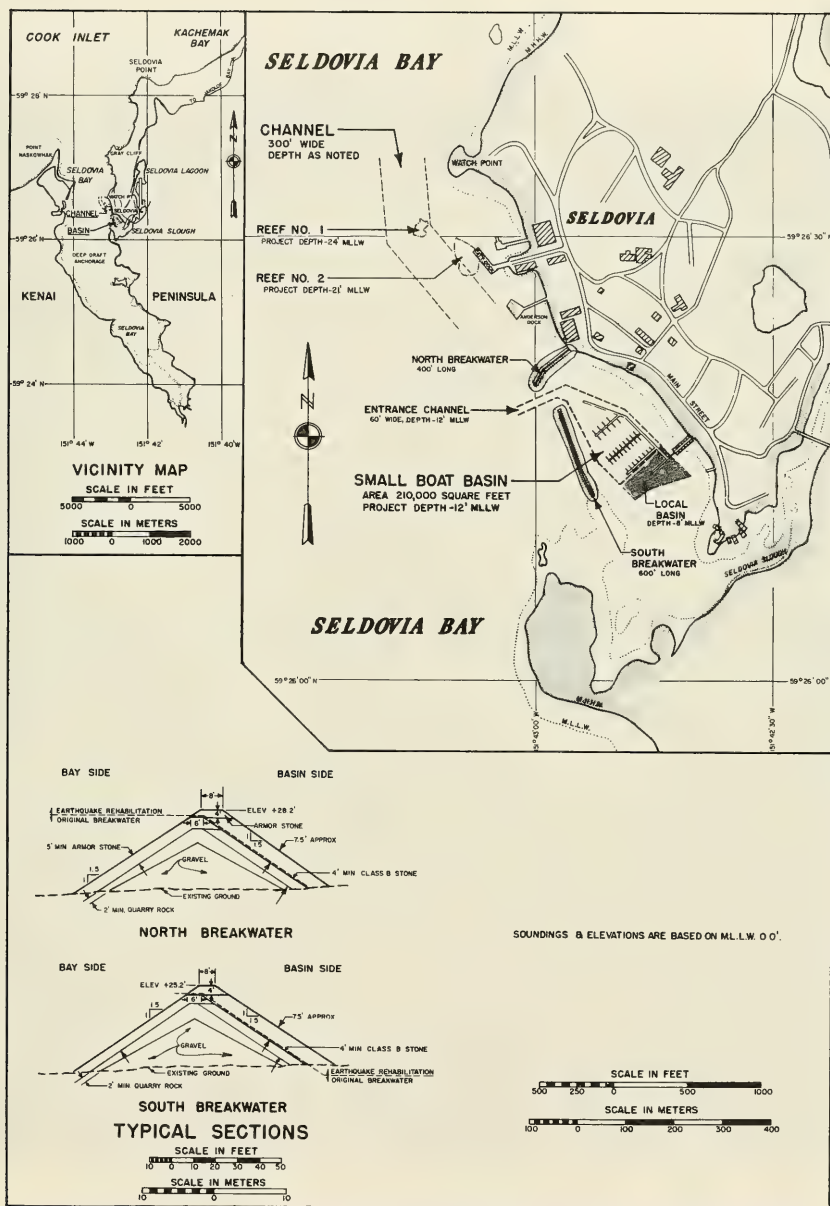
Figure 42. Site layout of Seldovia Harbor, Alaska (revised 1981)

1964	The basin subsided 3.8 ft in an earthquake. The breakwaters were repaired with a 7.5-ft-thick layer of rock on the basin side and a 4-ft-thick layer of armor rock on the crest, raising the crest elevations 0.2 ft over the original design heights, and widening the crests to 8 ft. The repair work required a total of 26,877 tons of stone. Cross sections of the rebuilt breakwaters are shown in Figure 42.
1985	The harbor is illustrated in Figure 42, and an aerial photograph of the harbor is presented in Figure 43. There have been no reports of needed repairs or rehabilitation since 1964.

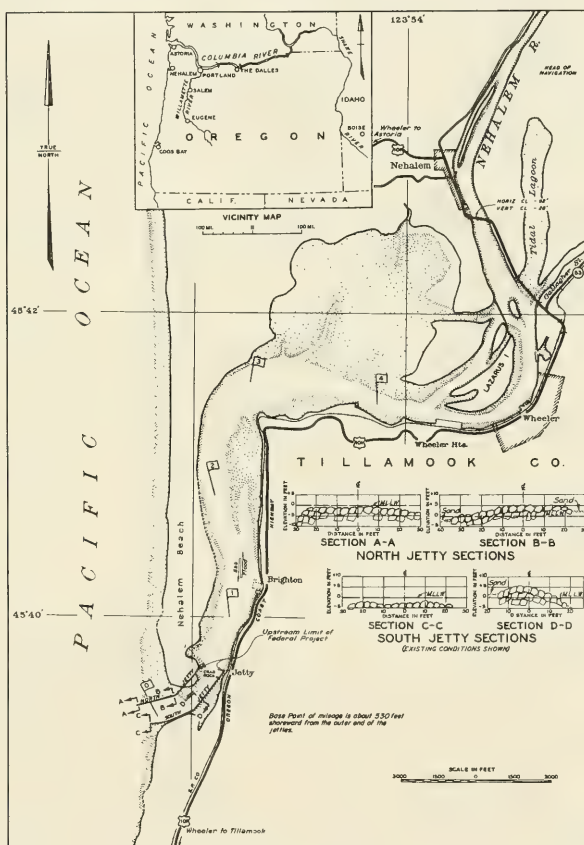
Figure 57. Site layout of Nehalem Bay, Oregon (revised 1979)

Date(s)	Construction and Rehabilitation History
1981 (Cont)	required an estimated 66,900 tons of class "A" stone, 104,000 tons of class "B", 40,300 tons of core stone, and 10,500 tons of bedding stone. Class "A" stone had a minimum weight of 7.0 tons and an average weight of 9.3 tons; class "B" stone had a minimum weight of 4.2 tons and an average weight of 5.6 tons. All weights were based on a unit weight of 170 pcf. Stone placement during construction was not as precise as desired due to inexperience of the contractor. However, the stones were sufficiently overweight that the jetties should be stable.
1985	The harbor and cross sections of the jetties are illustrated in Figure 57. The jetties are in good condition at this time.

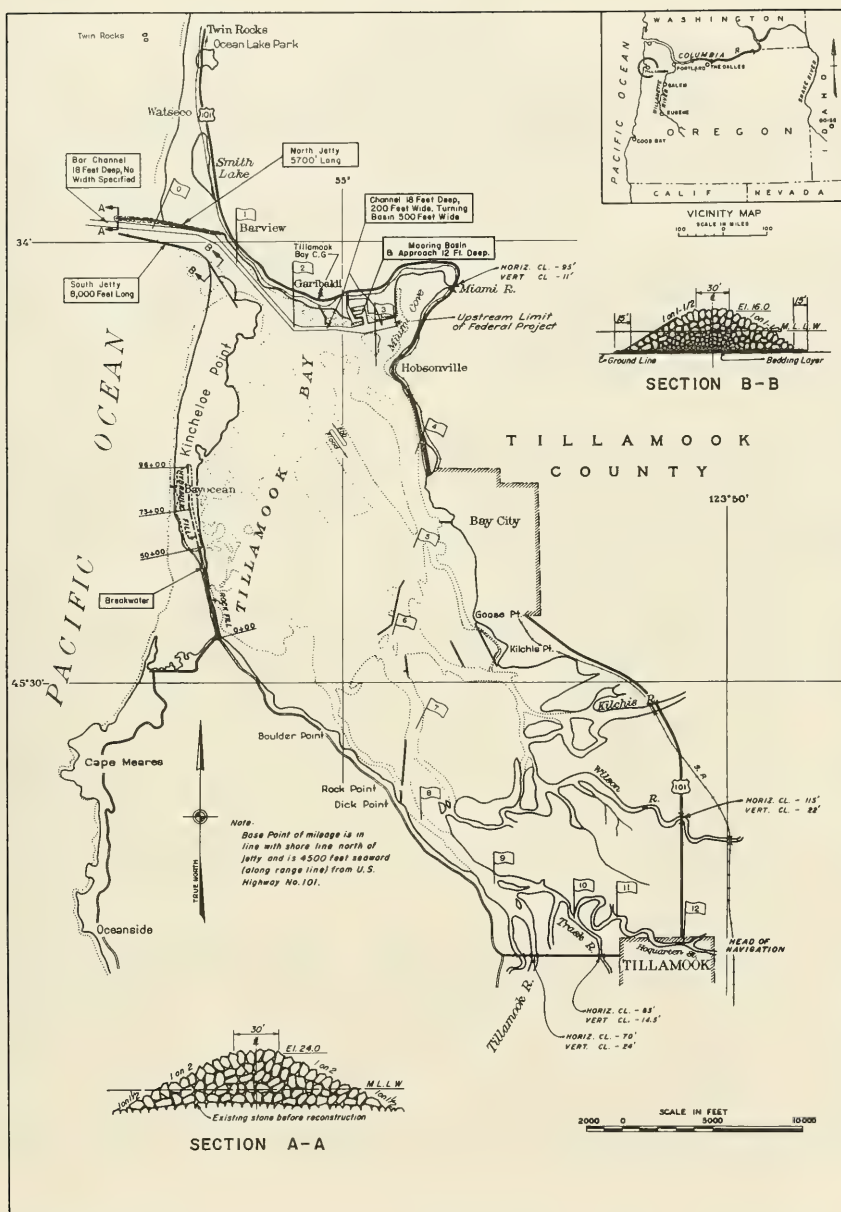
Date(s)	Construction and Rehabilitation History
1978- 1979	The south jetty was extended to 8,000 ft.
1985	The harbor and cross sections of the jetties are illustrated in Figure 63. The head of the north jetty has received some damage from extreme wave conditions, and the outer portion of the south jetty has shown some subsidence. No repairs or rehabilitation are planned at this time.

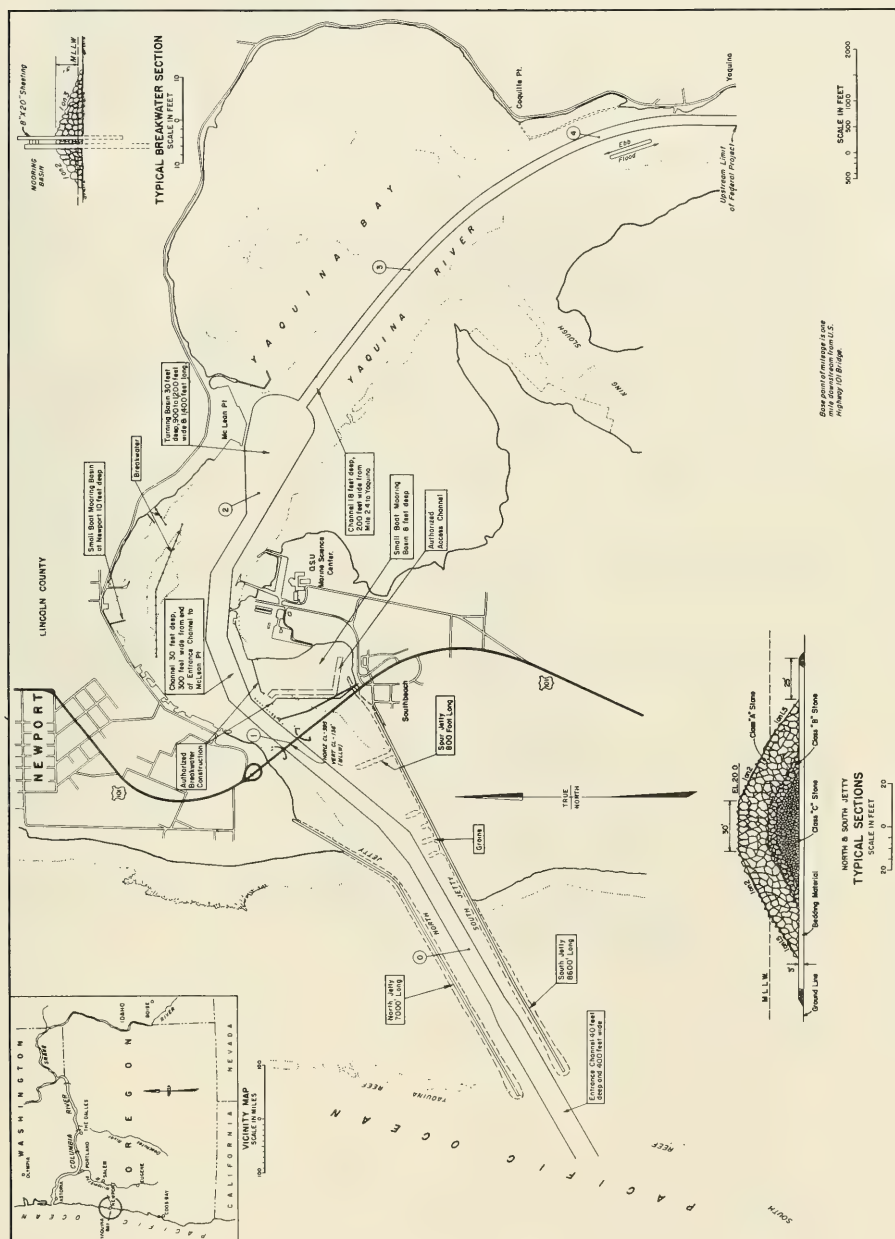
1985	The harbor and cross section of the jetties are illustrated in Figure 65. The south jetty shows some damage but is serviceable, and no repairs are planned at this time. Studies are currently being conducted for major rehabilitation of the north jetty.

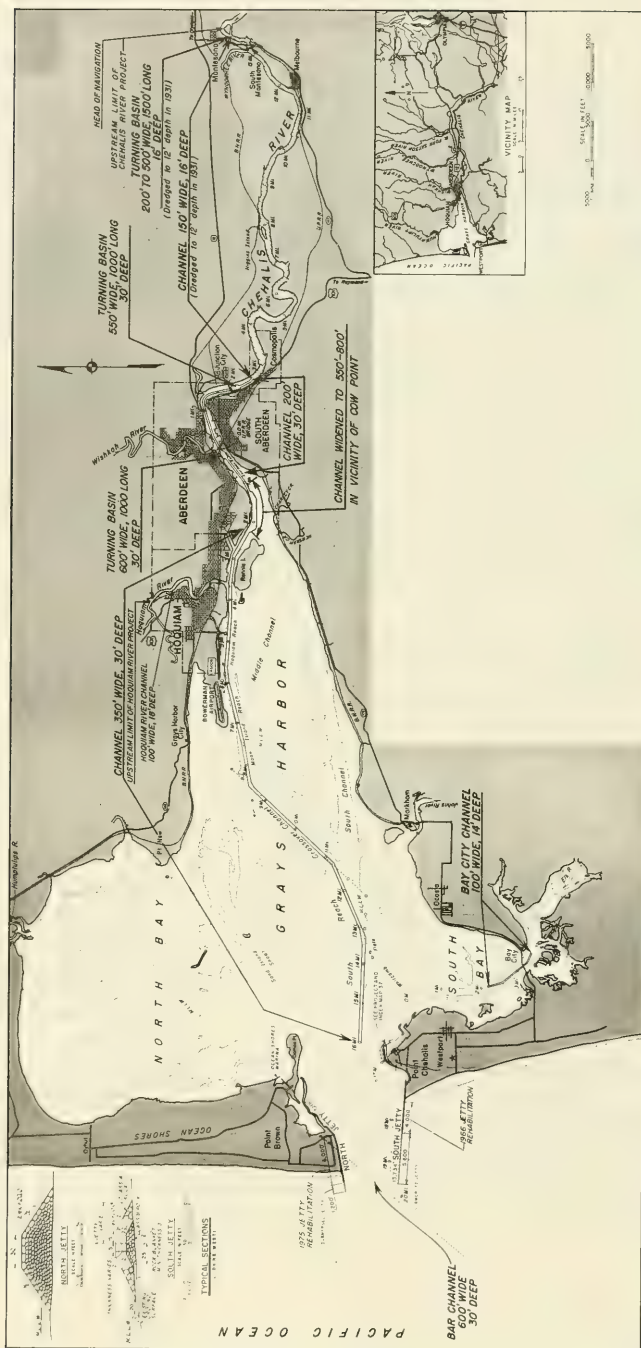
1953- 1962	An additional 1,700 ft of south jetty subsided to depths of approximate mllw, leaving less than 5,000 ft of the jetty near grade.
1961	Only 2,000 ft of the reconstructed portion of the north jetty remained at or near grade.
1966	The south jetty (4,000 ft) was reconstructed to +8 ft mllw.
1969- 1971	A hydraulic model study of Gray's Harbor was conducted.
1975- 1976	A 6,000-ft length of the north jetty was rehabilitated.
1985	The harbor and cross sections of the jetties are illustrated in Figure 70. The outer 1,200 ft of the north jetty and 5,600 ft of the south jetty are submerged. There is some deterioration of the south jetty, with severe scour along the channel side toe of the jetty. The overtopping conditions on the north jetty in the area of the 1975 rehabilitation work threatens a roadway on the land side of the jetty.

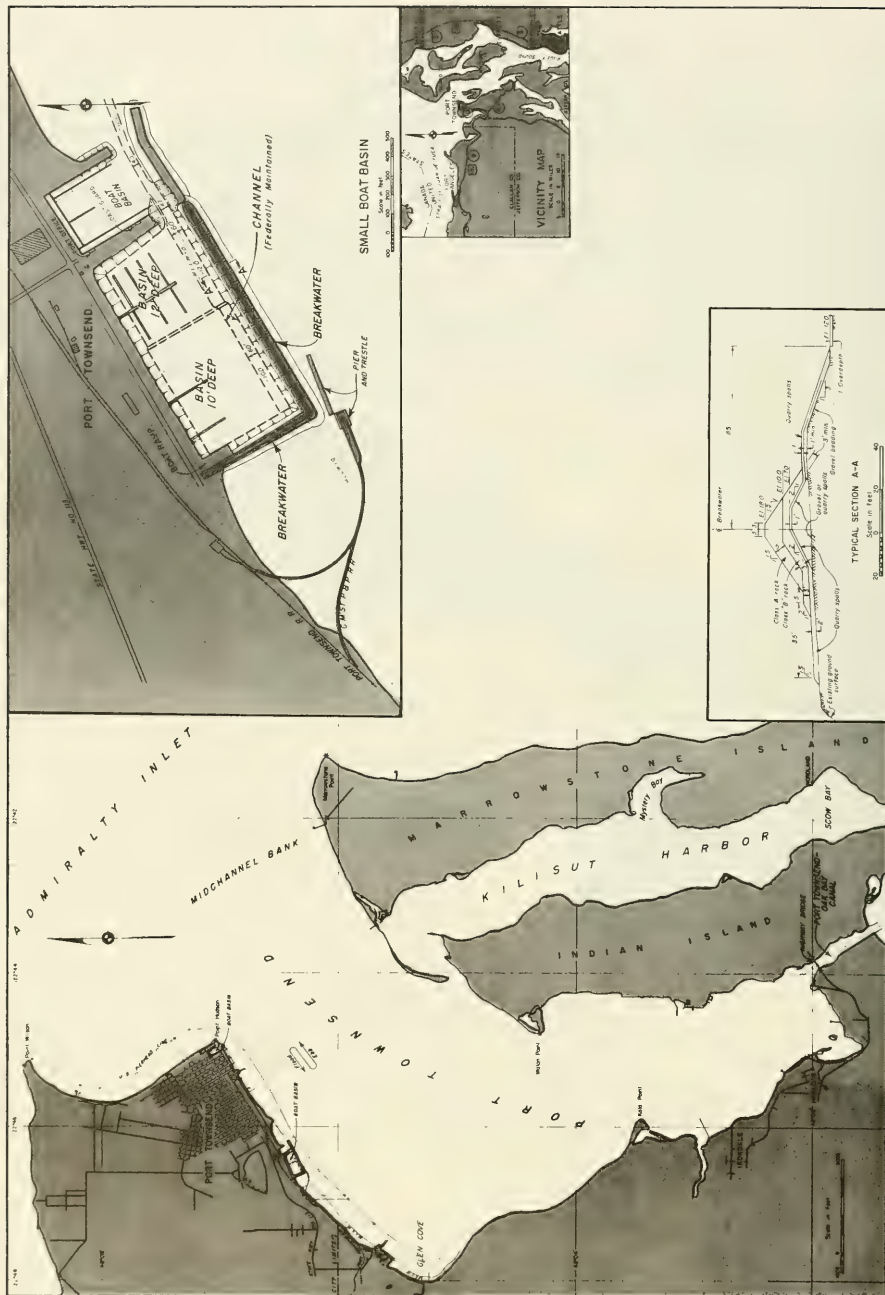
Figure 76. Site layout of Port Townsend, Washington (revised 1979)

<u>Date(s)</u>	<u>Construction and Rehabilitation History</u>
1958	Improvements to the small-boat basin were authorized.
1962	The final design recommendations were submitted.
1964	Construction of 1,946 ft of the rubble-mound breakwater and dredging of the adjacent basin were completed. The breakwater was constructed to +18 ft mllw for a 5-ft design wave. An access channel was cut through the existing breakwater to -12 ft mllw with a width of 50 ft at the bottom of the gap and side slopes of 1:2.
1985	The harbor and cross section of the breakwater are illustrated in Figure 76. There are no records of needed repairs or rehabilitation.

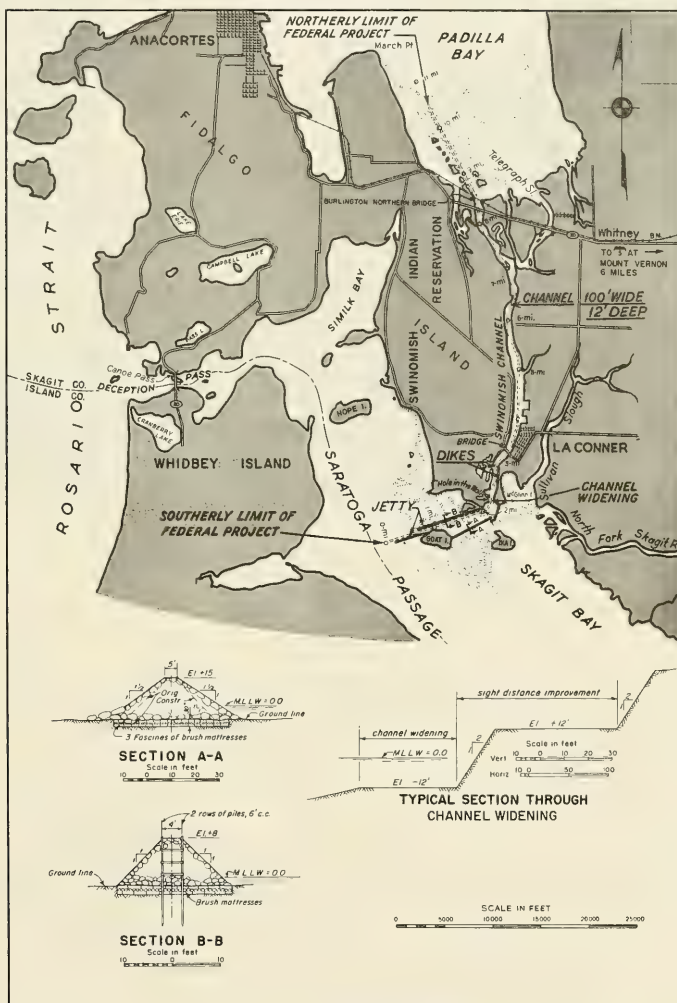
Figure 79. Site layout of Swinomish Channel, Washington (revised 1979)

Date(s)	Construction and Rehabilitation History
1985	The jetty layout and cross sections of the jetties are illustrated in Figure 79. The north jetty shows obvious deterioration, and the south jetty and Goat-McGlinn Island jetty appear in good condition.

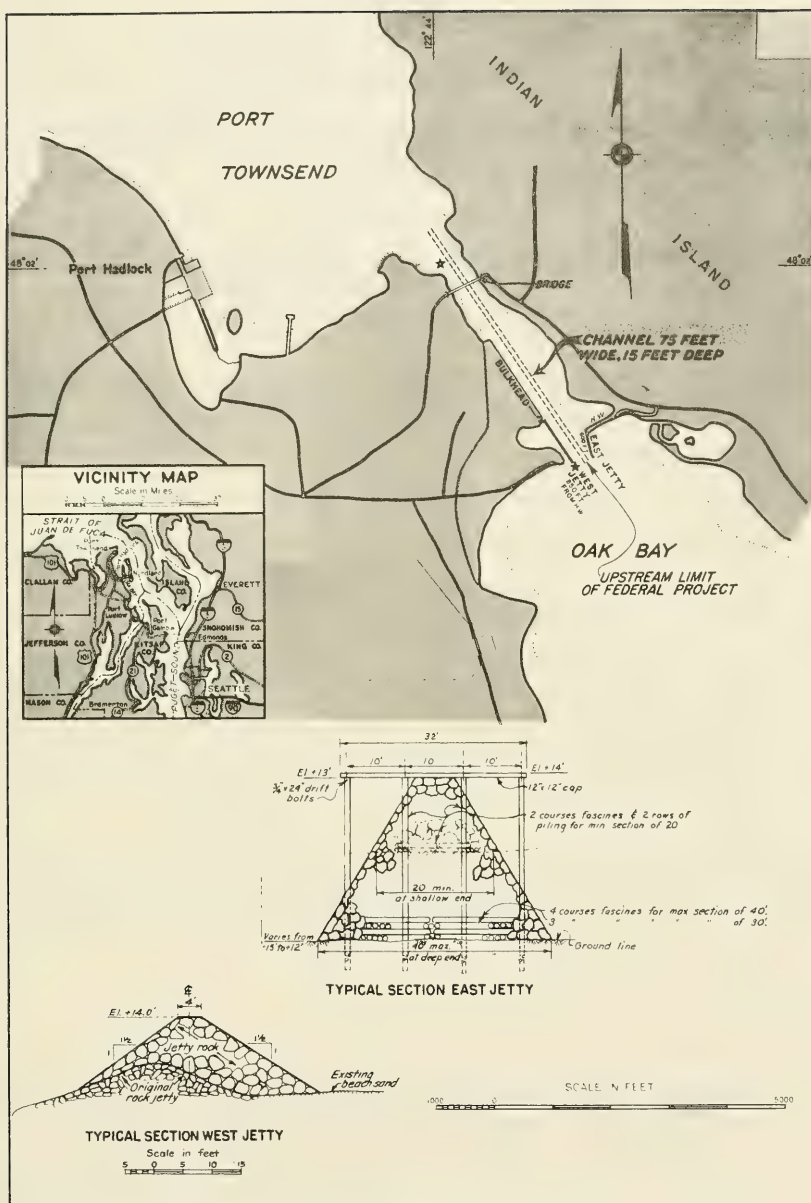
Figure 80. Site layout of waterway connecting Port Townsend and Oak Bay, Washington (revised 1979)

Date(s)	Construction and Rehabilitation History
1913	The project was adopted.
1915- 1916	The east jetty, west jetty, and bulkheads were constructed. The jetties were constructed of brush, pile, and stone with a 4-ft-wide crest and 1:1 side slopes. The west jetty was 550 ft long; the east jetty was 600 ft long. The bulkheads were constructed of brush, pile, and timber.
1925	The jetties and bulkheads were rehabilitated with 1,153 tons of rock.
1937	The rehabilitation work was performed on the east jetty by placing 393 tons of rock.
1961	The west jetty was rehabilitated with 12,173 tons of jetty rock to a crest elevation of +14 ft mllw, a crest width of 4 ft, and side slopes of 1:1.5.
1985	The jetty layout and cross sections are illustrated in Figure 80. There is no record of repairs or rehabilitation since 1961. The west jetty is in good condition. The east jetty shows some deterioration but is stable and functional.

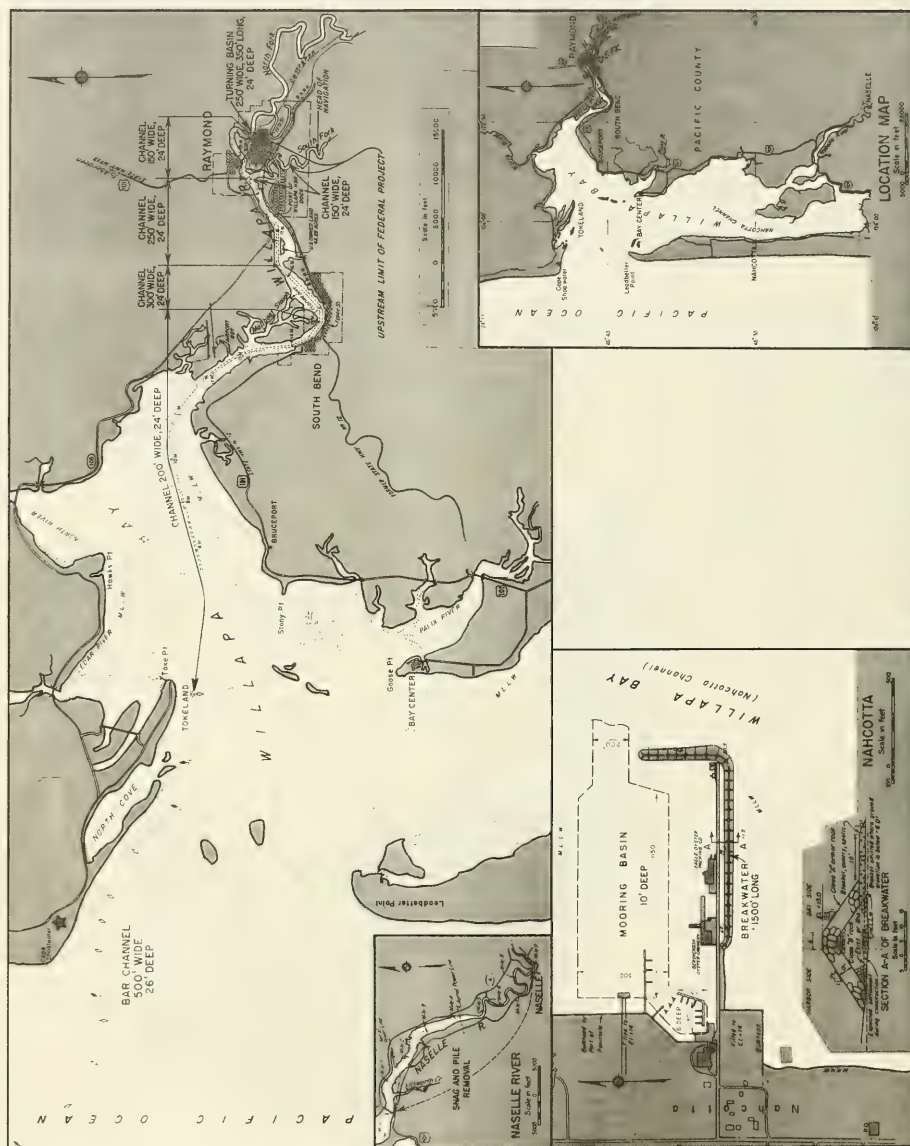
<u>Date(s)</u>	<u>Construction and Rehabilitation History</u>
1916	Willapa River and Harbor project adopted.
1954	The Willapa River and Harbor project was modified to include the mooring basin and the breakwater at Nahcotta.
1957	The breakwater design at Nahcotta was modified to conform to requests by local interests.
1957- 1958	The Nahcotta breakwater was constructed. The 1,500-ft-long breakwater was of rubble-mound construction, with the crest at elevation +15 ft mllw, width of 6 ft, and side slopes of 1:1.5. The landward end tied into an existing oystershell mound at the landward end of Nahcotta Wharf. A 2-ft-thick layer of quarry spalls was extended 15 ft from the seaward toe on the channel side of the breakwater to protect against toe scour. The breakwater required 43,700 tons of rock to complete.
1958	The Nahcotta mooring basin and channels were dredged.
1985	The harbor layout and breakwater cross sections are illustrated in Figure 82. There are no reports of needed repairs or rehabilitation for the breakwater.
